**Subject: Preliminary Proposal for Rockfall Remediation along Stillwater River Road,  
Stillwater County, Montana**

Project 15-3359G

Re: Geotechnical Reconnaissance, Stillwater River Road Rock Slide, West of Absarokee, Montana

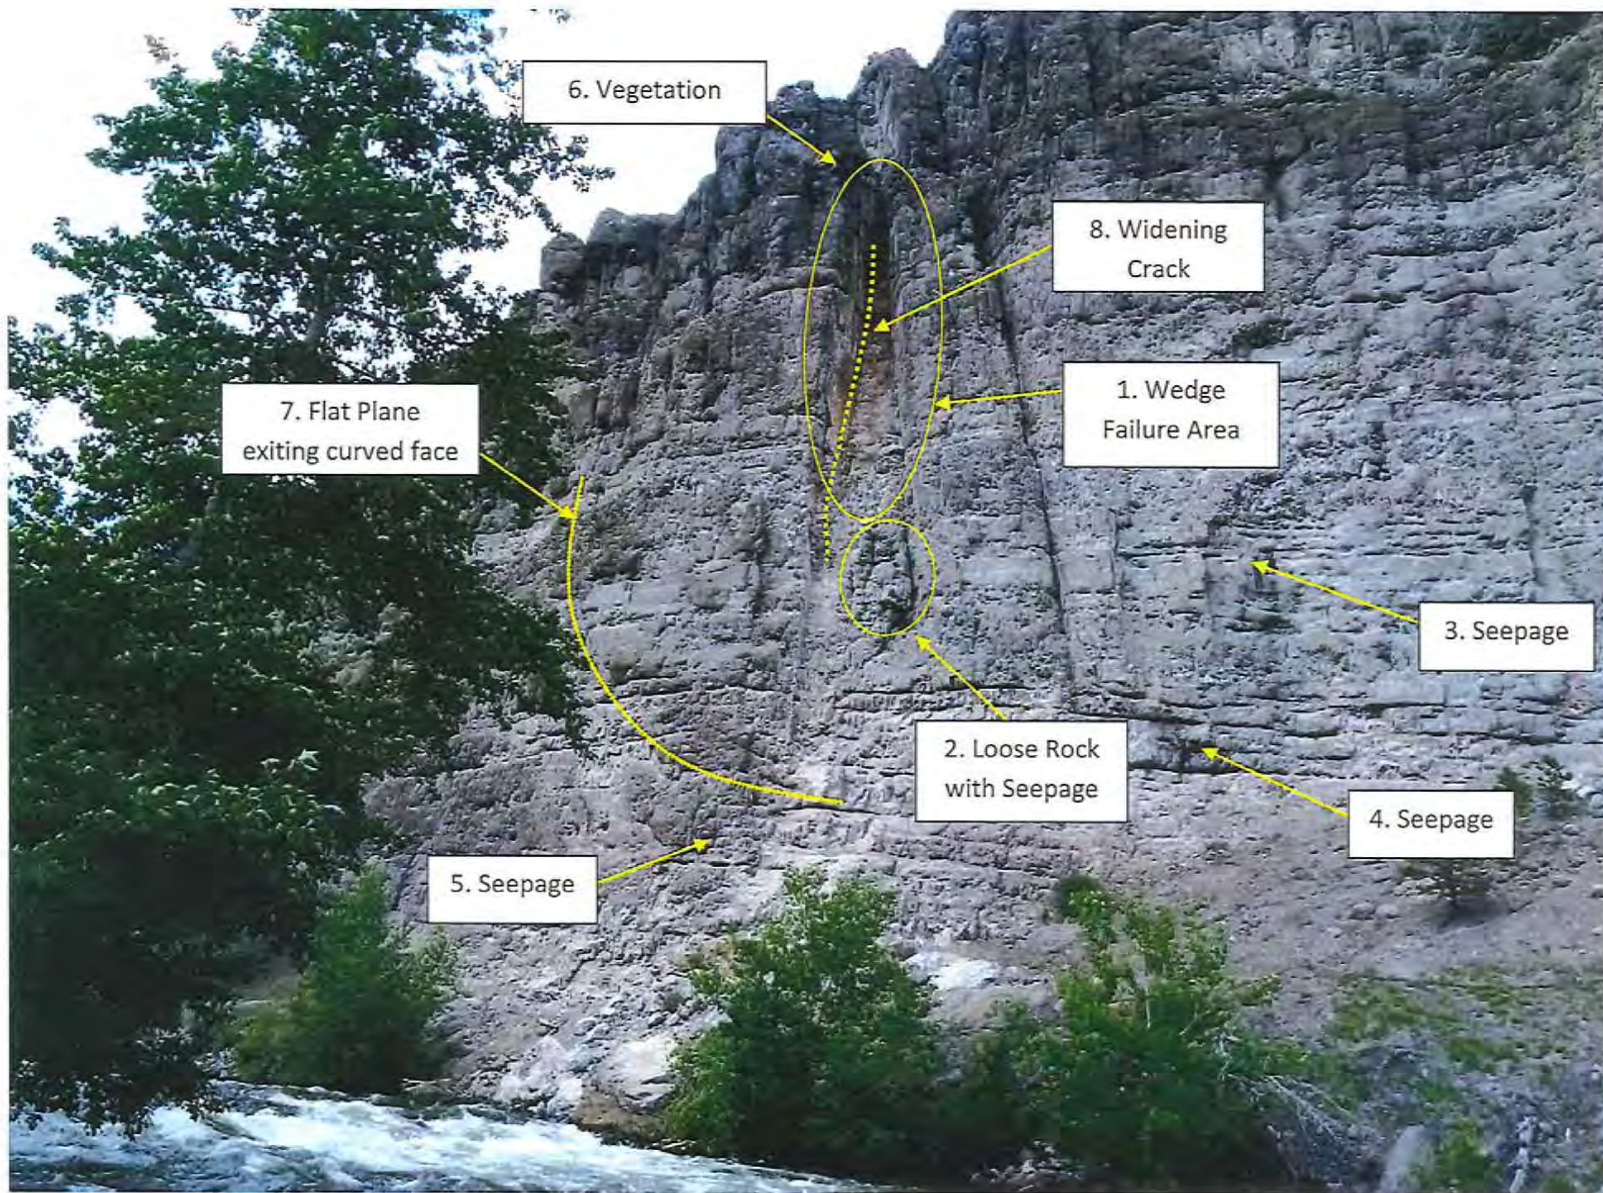
Figure 1

The rock slide was a wedge-shaped failure approximately 50 feet long, 5 to 10 feet wide and about 5 feet deep. The wedge failure is labeled #1 on the attached photos. The bottom of the failure was about 30 to 40 feet above the roadway. In the area around the rock slide, Stillwater River Road travels beneath the rock face, which is approximately 100 to 150 feet tall and 1/4-mile long in total. There is no shoulder either between the road and the rock face or the road and the slope leading down to the Stillwater River. The Stillwater River is about 15 feet below the road surface elevation with an approximately 1H:1V slope between the river and the road.

In several areas around the rock slide, water was observed seeping from the rock face. These active seeps were located approximately 10 to 15 feet away from the wedge failure and are labeled as #3, #4, and #5. Label #2 is a portion of rock hanging just below the wedge failure. It was observed to be damp and possibly seeping, but dripping water was not observed. While on site, we also observed clouds of dust escaping from joints in the rock near label #2. This suggests very loose rock and active movement was occurring.

Above the wedge failure area, vegetation was observed, which indicates a relative flat spot (perhaps a ledge) above the wedge failure having enough moisture to establish plants. This likely allowed water to accumulate behind the failed wedge. This water can saturate the rock increasing its weight, and when combined with the joint lubrication, likely contributed to the rock wedge failure.

Numerous areas of the outcrop appear to be unstable. In the vicinity of label #2, several suitcase-sized rocks were observed which appeared to be relatively loose. Outside of the immediate wedge failure area, other portions of the rock face appear to have a high risk of wedge failures in the future. Areas #9 and #10 have discontinuities that intersect to create a wedge. They appear to be relatively stable when compared to the loose rocks in area #2, but the risk of failure still exists. A large rock mass is defined by the discontinuity shown with lines labeled #7 and #8. These discontinuities represent failure planes, and although no active movement was observed, there is a risk of future failure. This risk increases due to water saturation and seismic events.

During the reconnaissance, it was our opinion the road should remain closed due to the recent movement observed in the vicinity of label #2. We recommended monitoring of the observed seeps to assist in evaluating when to clear the debris and open the road.

In and around the existing wedge failure, portions of the rock face have similar joint conditions and are at risk of failing. Predicting the location and relative timing of a rock slide is extremely difficult. However, experts on the subject of rock mechanics can be hired to evaluate the probabilities of failure. In addition to evaluating the potential risk of failure, these experts can make recommendations for rock fall hazard mitigation. Possible mitigation approaches include rock scaling (removing loose rocks), rock bolting, rock netting, and rock fencing and/or barricades. These types of mitigation are extremely expensive and can likely only be applied to a small portion of the entire rock face, perhaps those areas determined to have the highest risk of failure. Geologic engineering companies that can be consulted include Golder Associates, Landslide Technologies, and Shannon and Wilson, who do a lot of landslide work on the west coast. Given the existing site conditions and limitations, there will always be some risk of rock failure along the 1/4-mile long rock face.
